NASA Technical Memorandum 78738

NINE PERCENT NICKEL STEEL HEAVY FORGING WELD REPAIR STUDY

Clarence P. Young, Jr., A. Harper Gerringer,
Troy G. Brooks, and Robert F. Berry, Jr.

July 1978

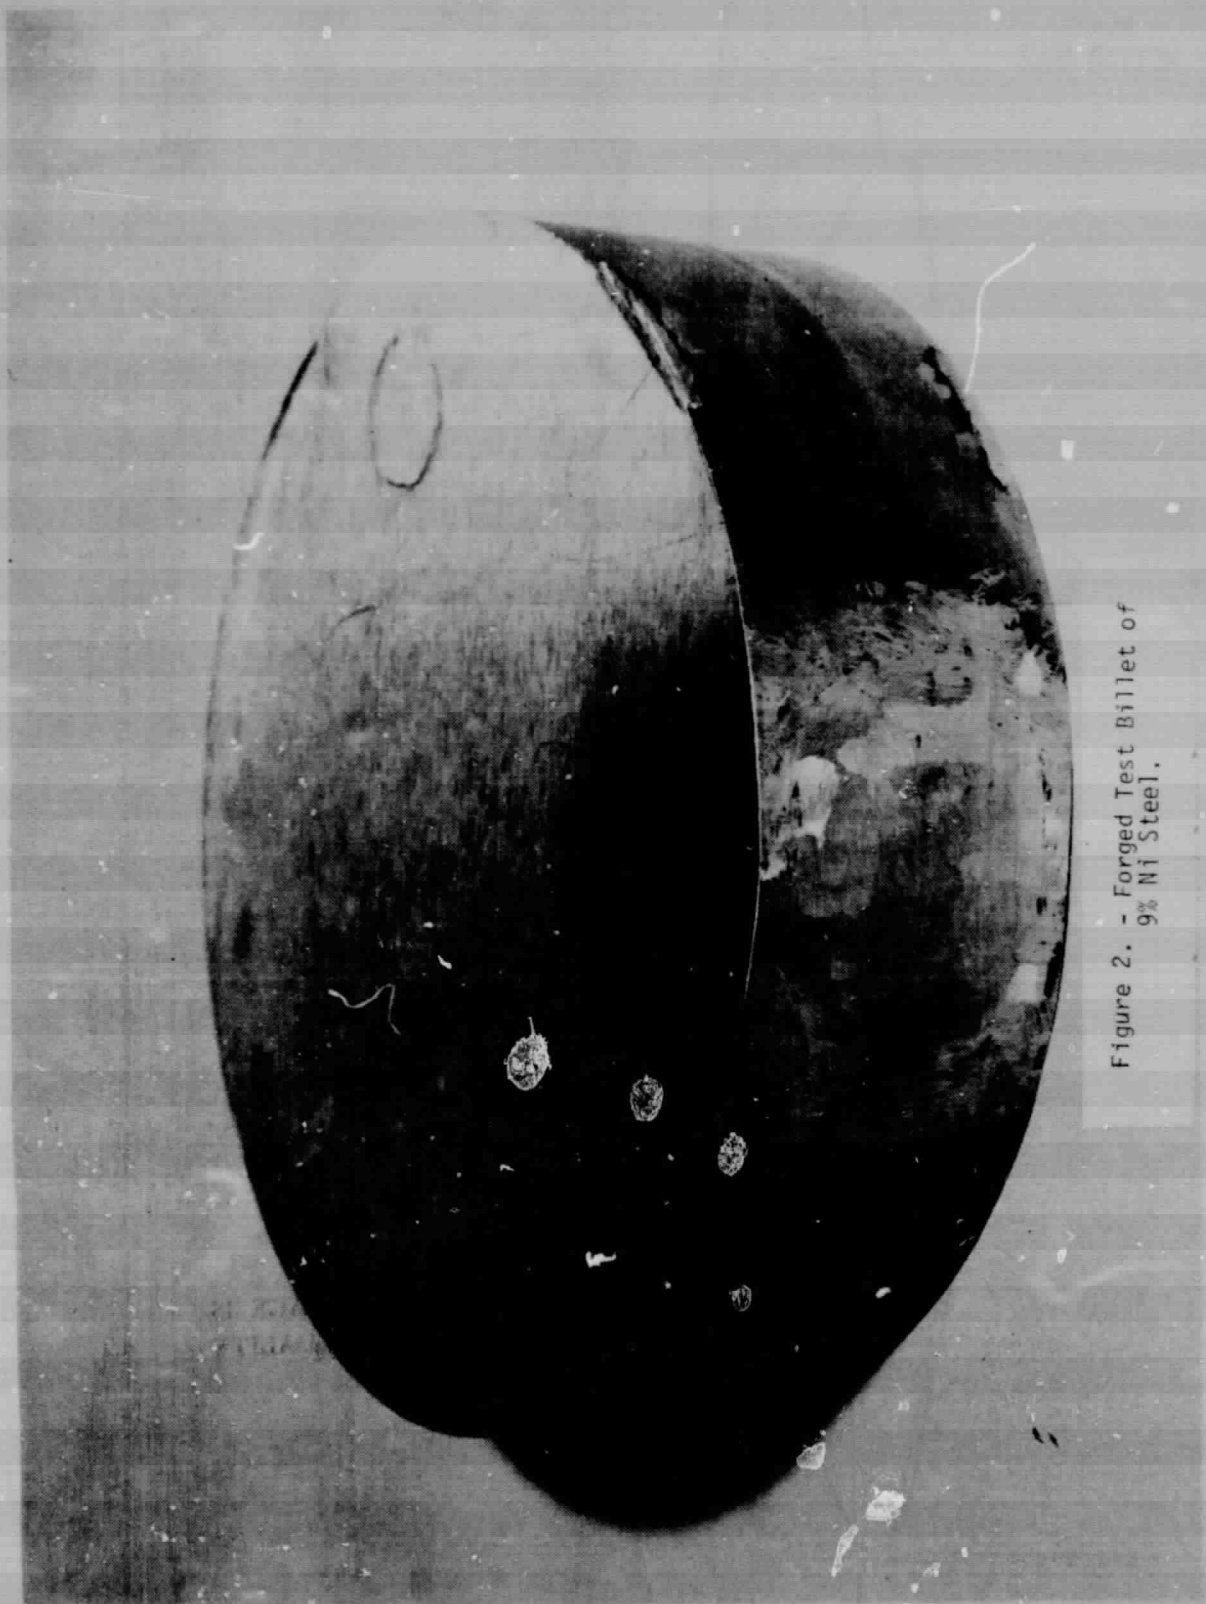
Figure 2. - Forged Test Billet of
9% Ni Steel.

Weld Repair Geometry. - The approach was to utilize existing forging material in 9% Nickel that would have the same chemical composition and heat treatment as the actual Fan Disk part. The test part was a 3 inch thick by 10 inch diameter 9% Nickel forging (disk shape) provided by the Fan Disk supplier (see figure 2). A weld repair geometry was selected for simulating the repair of a penny shape flaw 1" long by 0.5" deep flaw embedded near the mid thickness of the NTF Fan Disk Forging, (see figure 3 for photograph of the weld cavity placed in the forged part).

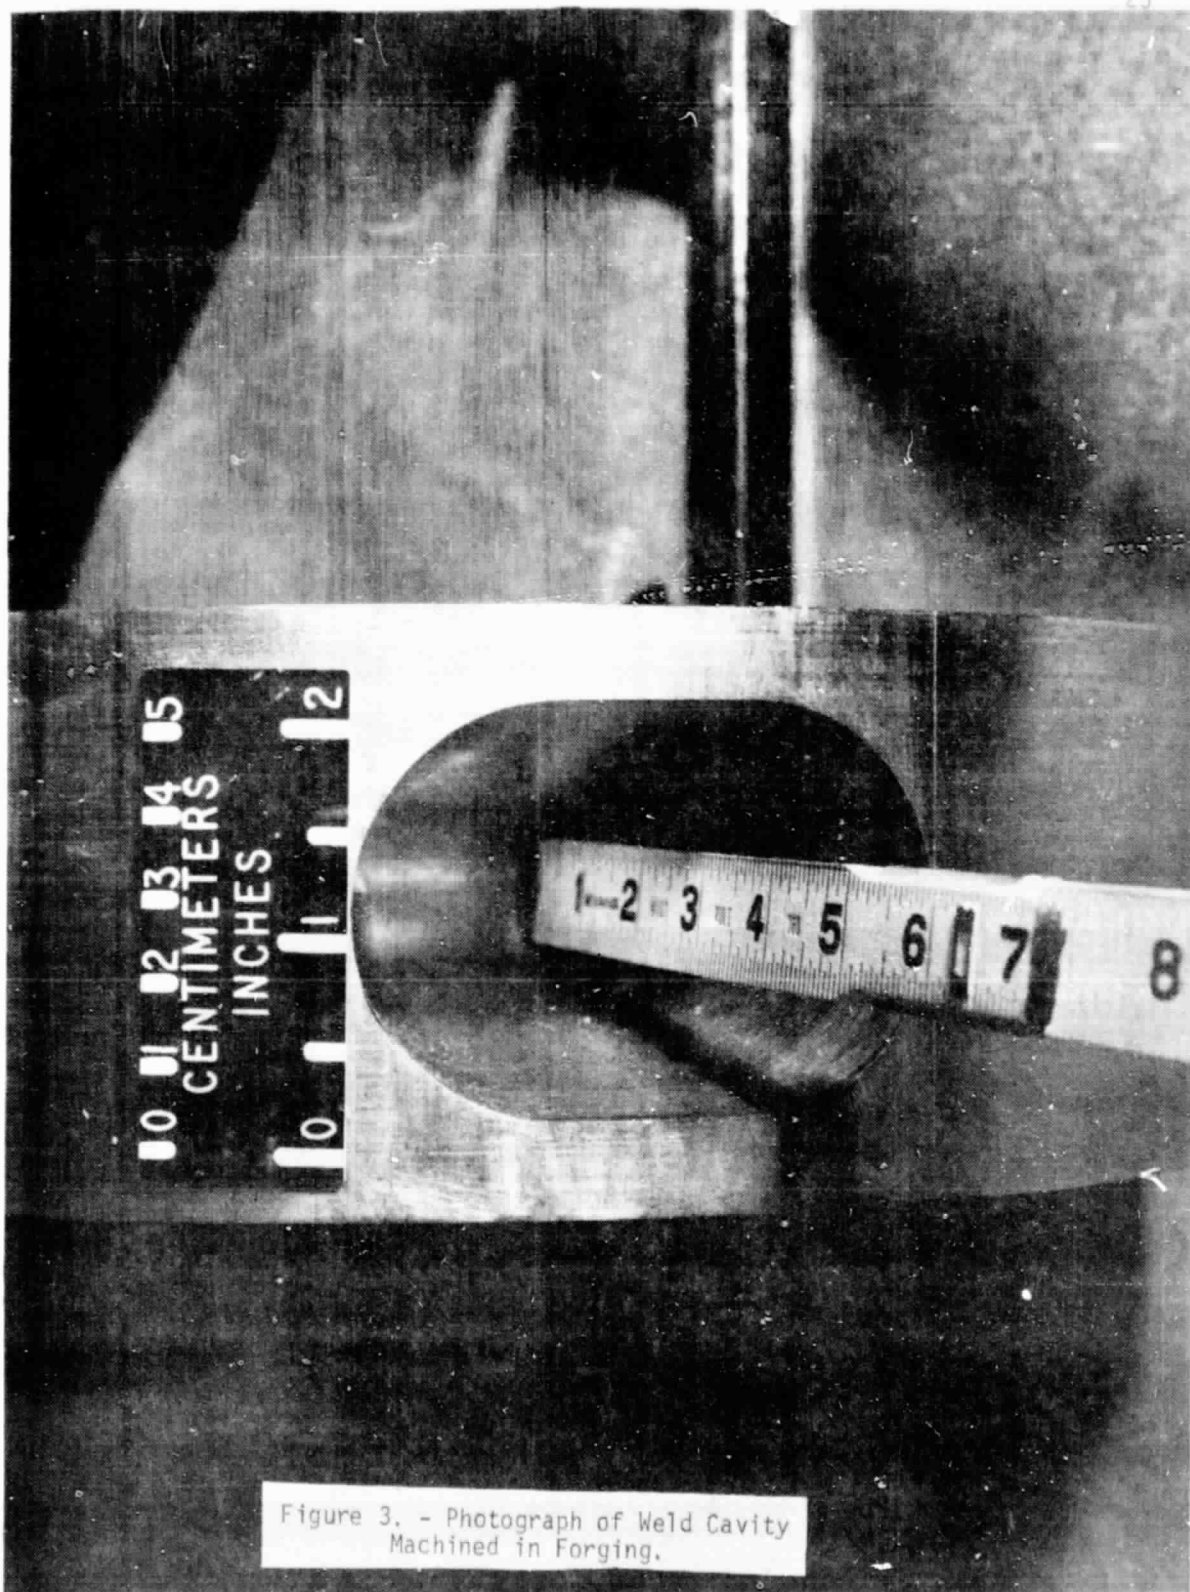
Figure 3. - Photograph of Weld Cavity
Machined in Forging.

Weld Repair Procedure. - Once the weld cavity was machined into the forging billet as shown in figure 3 the effective forging mass was increased by sandwiching the part with 1 1/4" plates welded to the part as illustrated in figure 4. This was done to simulate (at least to a degree) the mass effect of making such a repair in the large forging. The dimensions of the weld cavity are shown in the sketch of figure 5. The stepwise procedures used for filling the cavity with the weld material is given as follows:

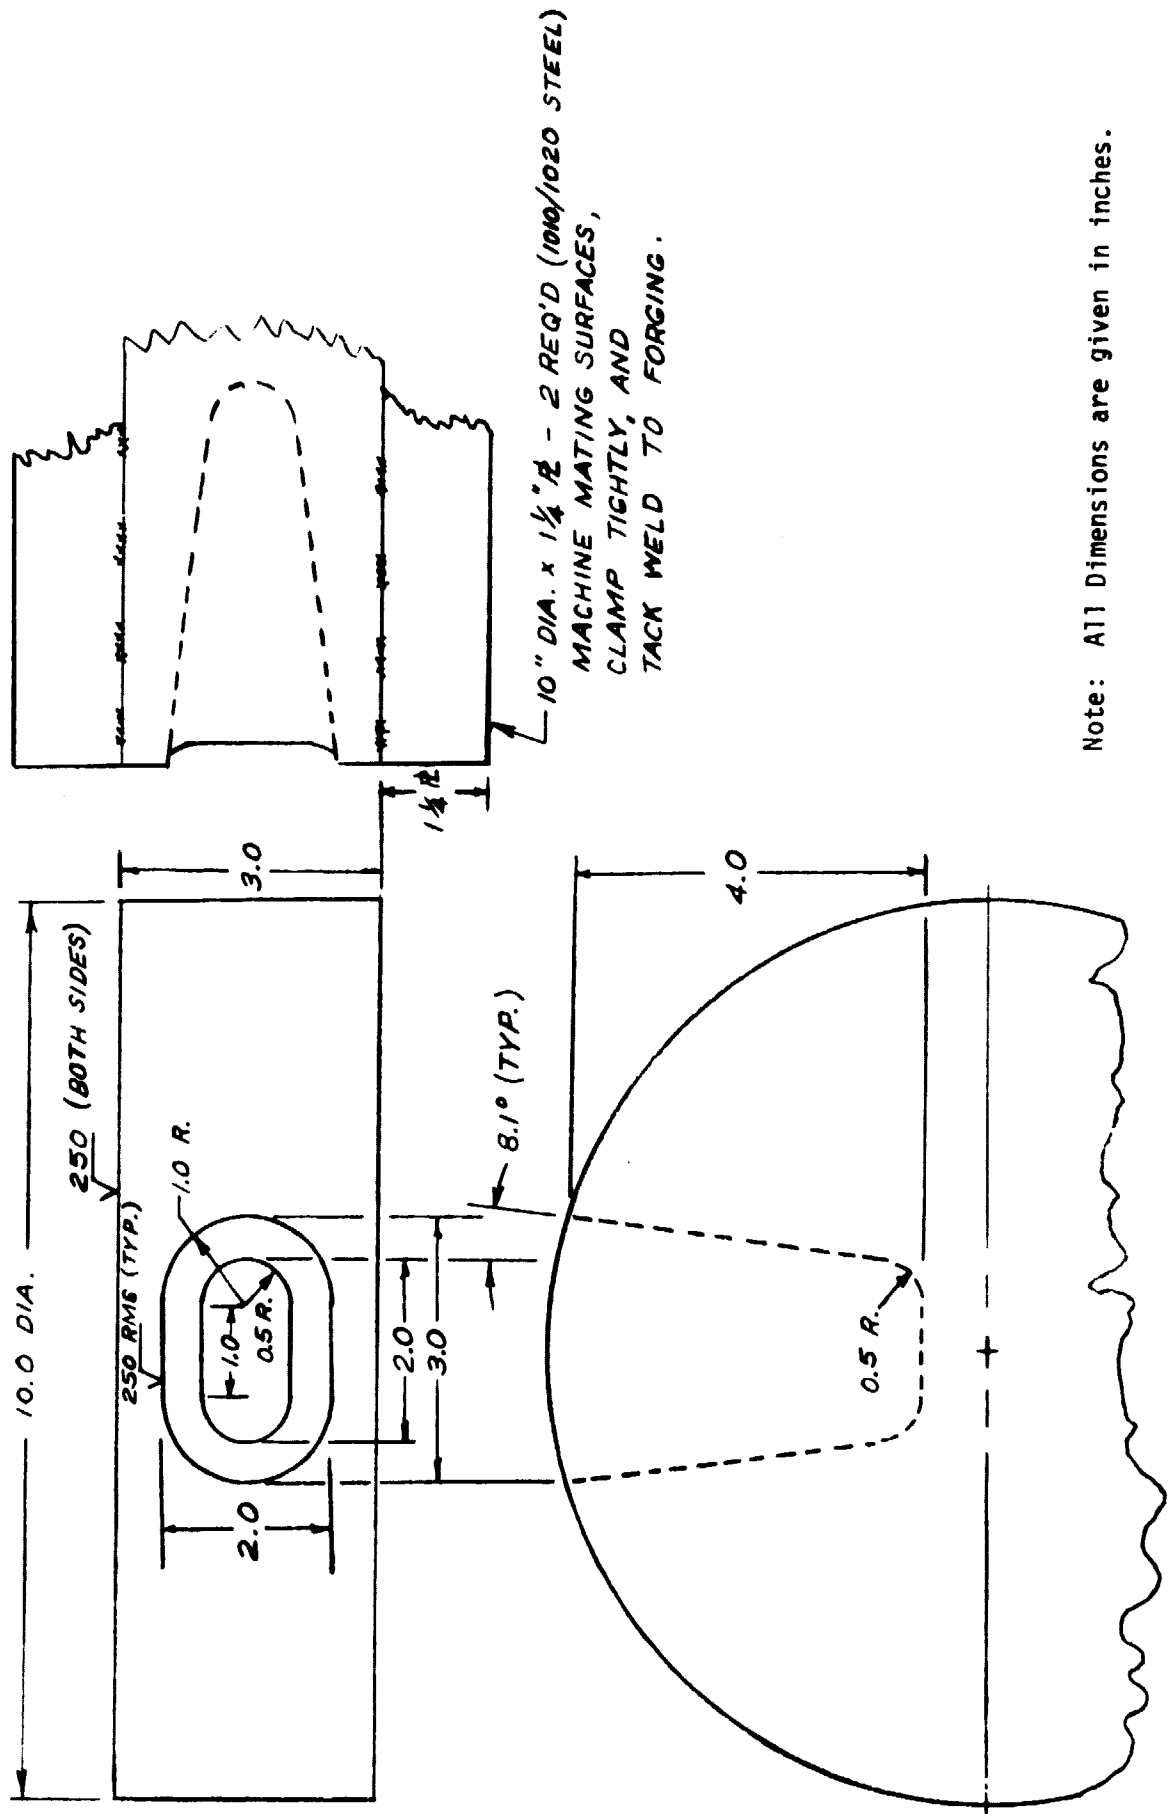
Figure 5. - Sketch Showing Dimensions of Weld Repair Cavity.

2. The included angle of 16.2 degrees for the cavity sides (see figure 5) was made to this extreme for two reasons: (1) To obtain greater cavity depth in the available material and (2) to evaluate the ability to produce sound welds under these restrictions. This minimized angle is partially responsible for the trapped slag found at the base metal/weld interface. For a cavity of this depth an included angle of 20 degrees or greater should be considered. An additional increase in angle and/or radius in the bottom portion of this type cavity would provide even better accessibility for slag removal tools and a more favorable electrode angle.

1. Although weldment properties and weld quality were relatively good, as shown by radiographic and mechanical properties tests, some modifications in both design and adherence to procedure deserves consideration. A reduction in the number and size of slag inclusions can be readily achieved by minor design changes and more critical attention to flux removal after each weld pass.

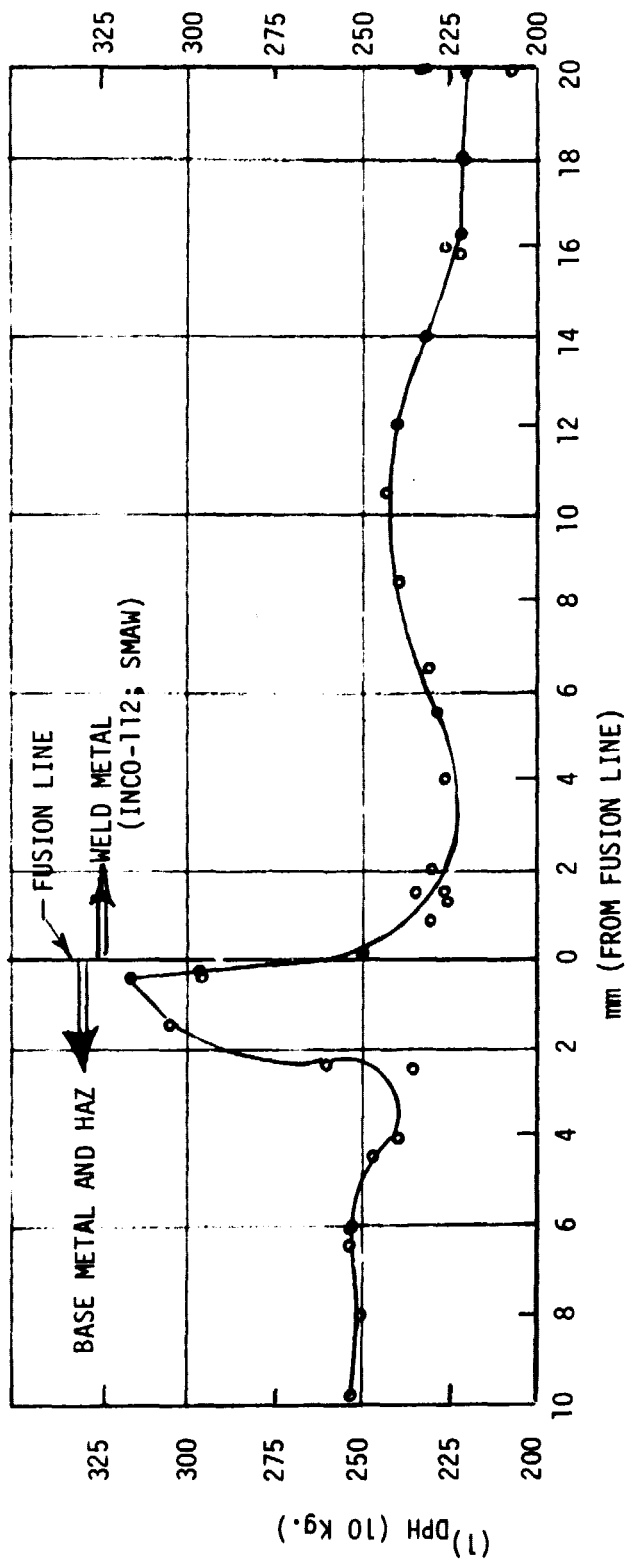
FIGURE 7. - HARDNESS PROFILE 9% NICKEL STEEL FORGING⁽²⁾ AND WELD⁽³⁾.

Heat Affected Zone. - The impact values were measured at or near the heat affected zone and were found acceptable (specimens numbers 16 and 17 in table III). In addition, hardness profiles were taken and are displayed in figure 7. The profile appeared typical with peak values of 315 DPH near the fusion line with values

in the weld material remaining fairly constant and very close to the parent material.
